**TMS320VC5507**  
**Digital Signal Processor**  
**Silicon Errata**

SPRZ217B  
April 2004 – Revised September 2004

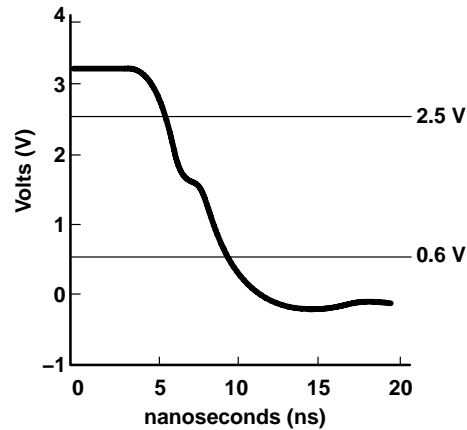
**Figure 3. Bad TCK Transition**

This phenomenon is observed when an erroneous clock edge is generated from the TCK signal inside the C55x™ DSP. This can be caused by several factors, acting independently or cumulatively:

A TCK edge that can cause this problem might look similar to the one shown in Figure 3. A TCK edge that does not cause the problem will look similar to the one shown in Figure 4. The key difference between the two figures is that Figure 4 has a clean and sharp transition whereas Figure 3 has a “knee” in the transition zone. Problematic TCK signals may not have a knee that is as pronounced as the one in Figure 3. Due to the TCK signal amplification inside the chip, any perturbation of the signal can create erroneous clock edges.

As the problem may be caused by one or more of the above factors, one or more of the steps outlined below may be necessary to fix it:

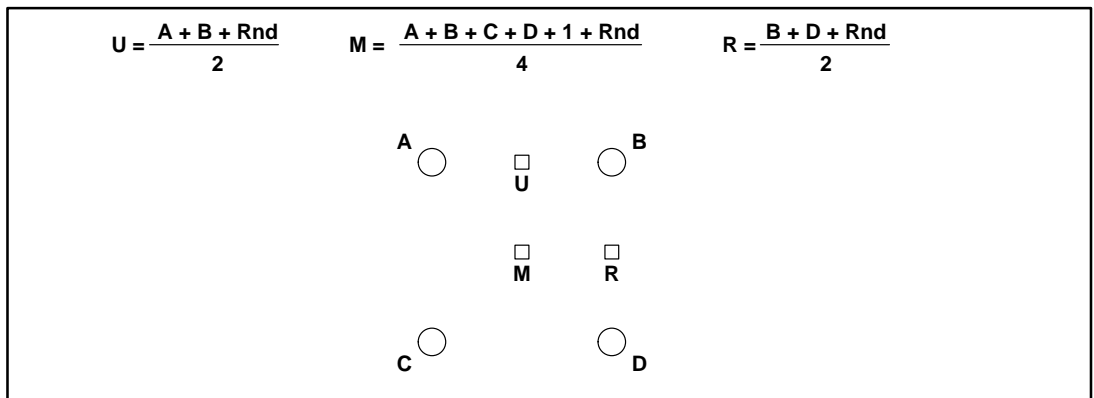
**Details:** The pixel interpolation computation is wrong by one pixel unit in “Decoder” mode, when “Rounding Mode” is set to zero and when half-pixel interpolation is performed in the middle of four full-resolution pixels (i.e., in the middle of two rows of pixels).

In “Decoder” mode, the Pixel Interpolator data path is configured to deliver two interpolated pixels per cycle. Each section of the data path implements the computations shown below, normalized according to video decoding standards:

U and R results are interpolated from lines and columns, respectively. M is computed from two following full-resolution pixels lines. Two U, R, or M results are computed during each cycle by the data path, according to the instruction being executed by the accelerator for the M results set (the results are denoted as M0 and M1). When “Rounding Mode” (Rnd in the above picture) is set to 1, the faulty data path section is implemented,  $M0 = (A+B+C+D+2)/4$ , which is the correct result; but when “Rounding Mode” is set to 0, the data path section implements  $M0=(A+B+C+D)/4$ . This is not correct and generates a bit exactness issue. The M1 result is always correct, regardless of the “Rounding Mode” state.
